# UNDERWATER BRIDGE INSPECTION REPORT

STRUCTURE NO. 5853

THE SOUTH BRANCH OF THE BUFFALO RIVER

DISTRICT 4 - CLAY COUNTY

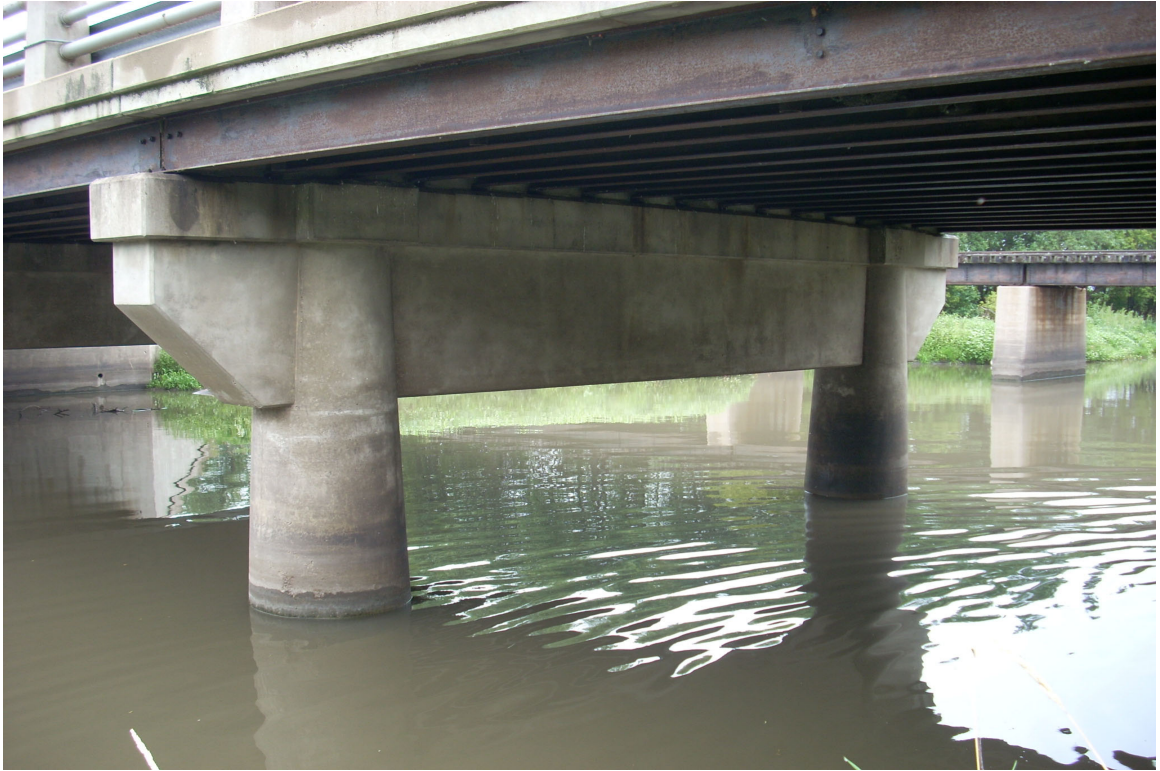
Photograph 1. View of Pier 1, Looking Northeast.

- 3 The concrete columns of Piers 1 and 2 were smooth and sound with random minor areas of poor consolidation with 1/4 inch maximum penetration.
- 4 The concrete of the abutments was typically smooth and sound with minor vertical and diagonal cracks at random locations, ranging in width from hairline to 1/8 inch.

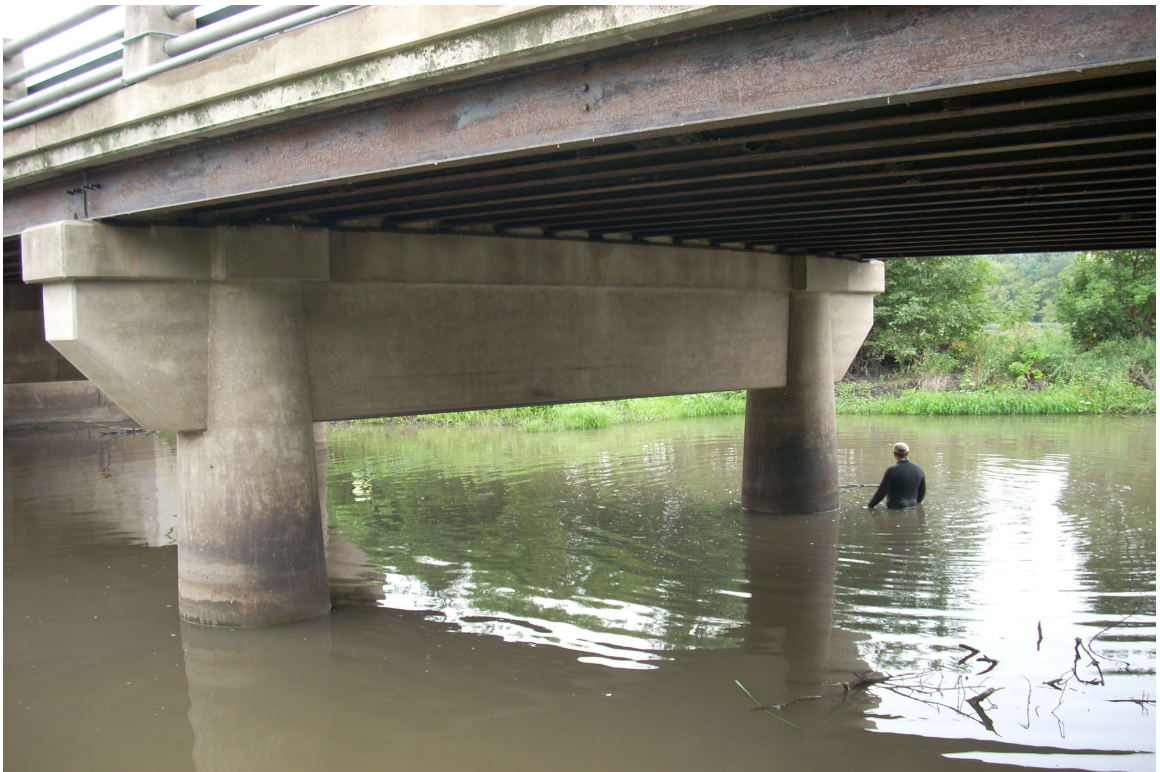
- 5 A light accumulation of 6-inch-diameter and smaller branch timber debris was observed at the upstream side of the upstream column of Pier 2. The debris extended from the channel bottom to the waterline and was approximately 10 feet long (E/W) by 5 feet wide (N/S).

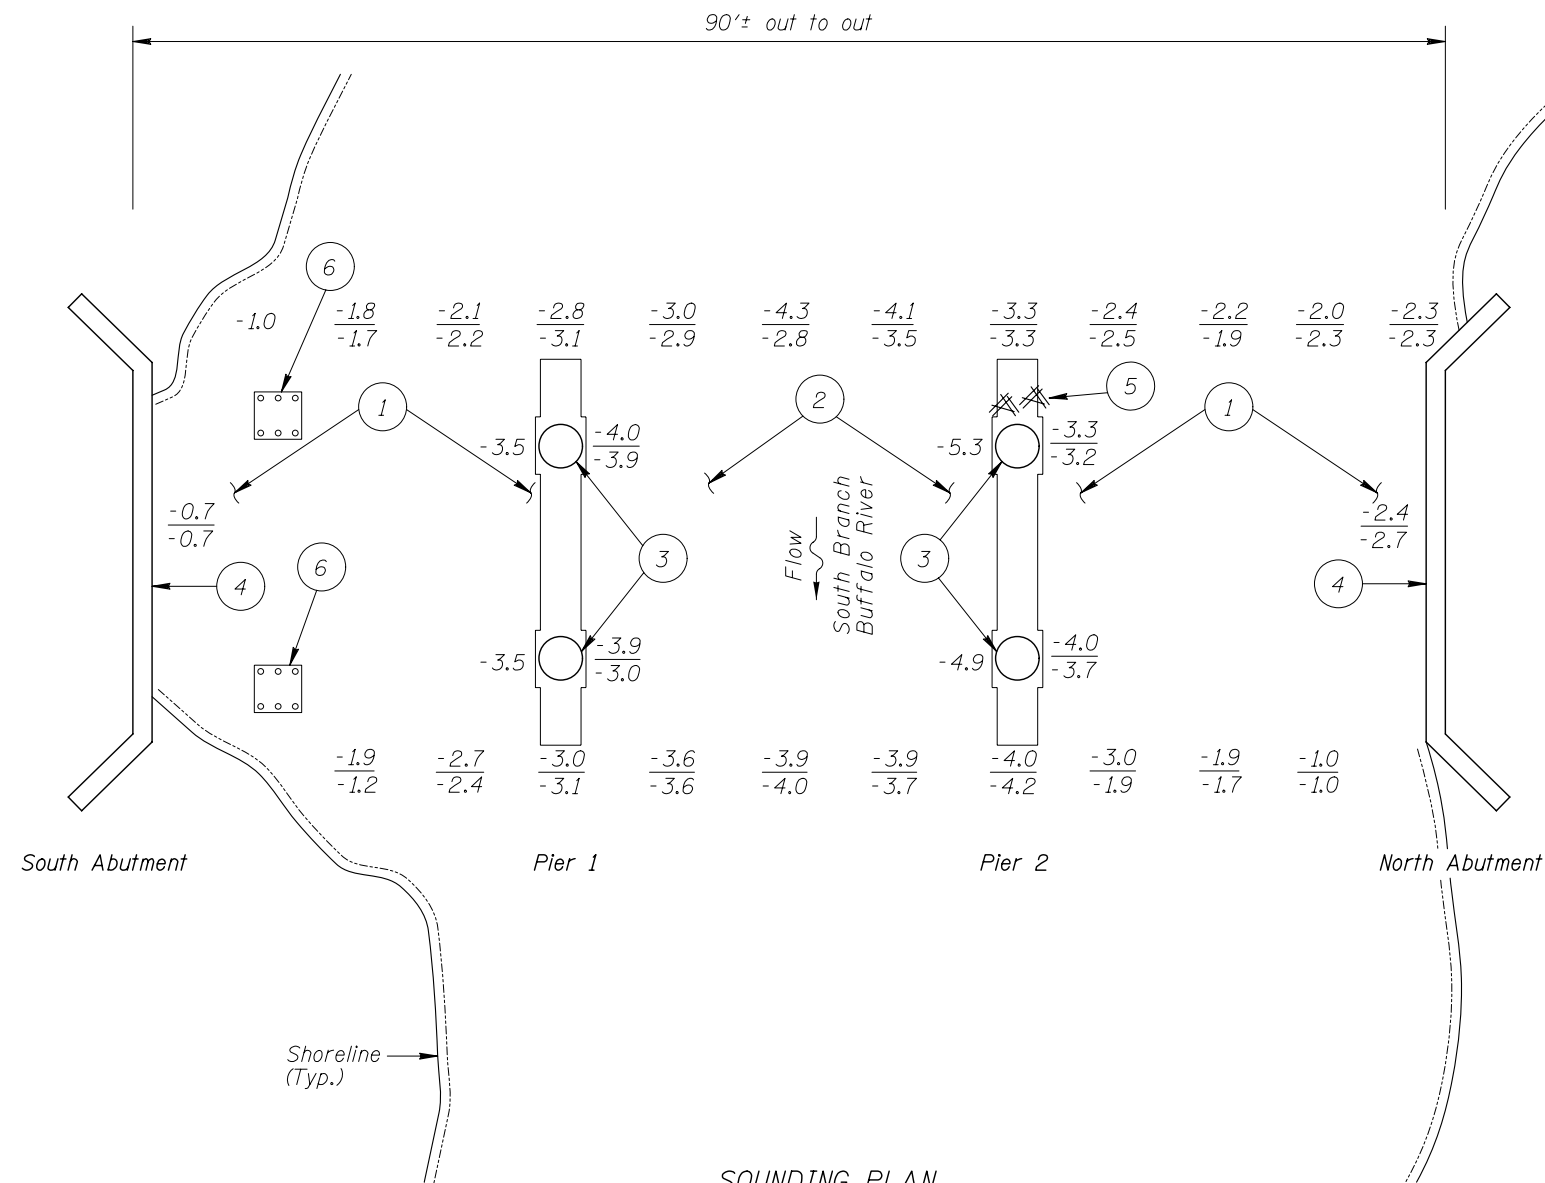
#### INSPECTION AND SOUNDING PLAN

- 1 The channel bottom between abutments and piers consisted of silt and random riprap up to 12 inches in diameter, with a maximum probe rod penetration of up to 2 feet.

- 2 The channel bottom in between the piers consisted of silty clay and riprap, up to 12 inches in diameter, with a maximum probe rod penetration of 2 inches.

- 6 Abandoned concrete columns (two total) were observed in the channel at 8 feet North of South Abutment. The columns were removed below the channel bottom; however, the rebar from the columns extended from the bottom up to 1 foot above the waterline.
